# TYLER PARK

## RENEWAL MASTER PLAN

OCTOBER 2010

ENVIRONS INC LANDSCAPE ARCHITECTS  
HERITAGE LANDSCAPES LLC  
MATTINGLY ENGINEERS, LLC  
STUDIO KREMER ARCHITECTS

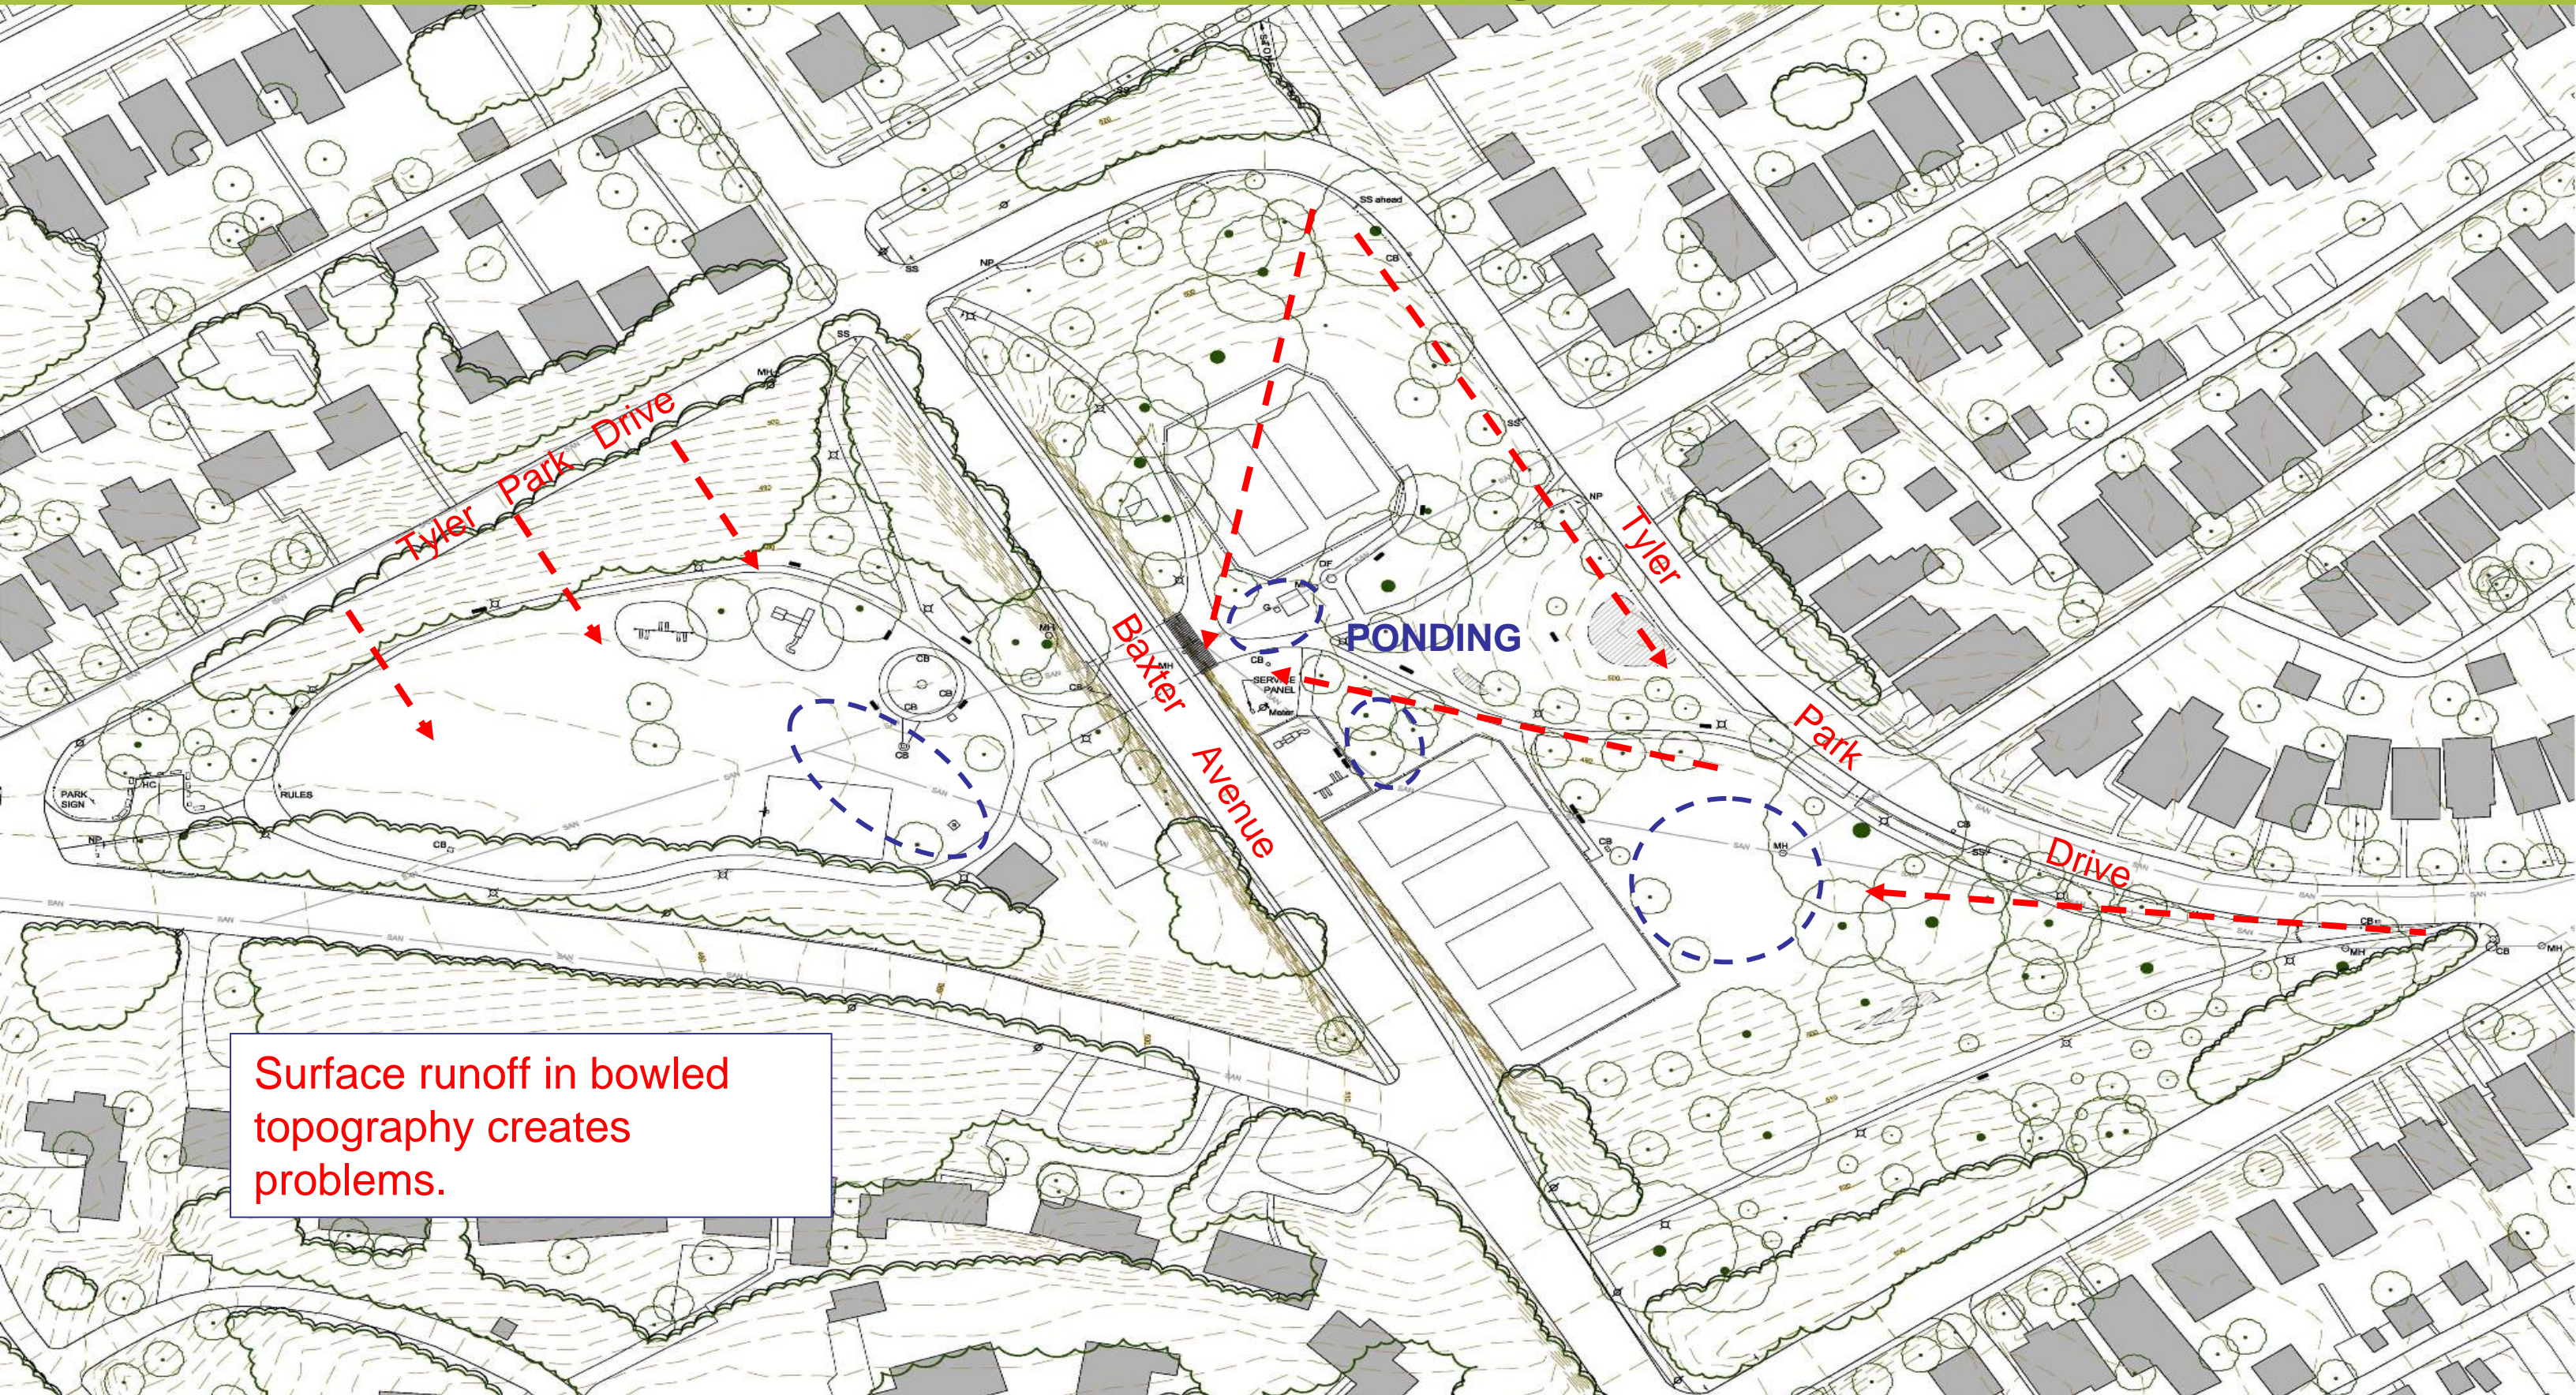
# Project Issues: Drainage & Erosion

Surface runoff in bowed topography creates problems.

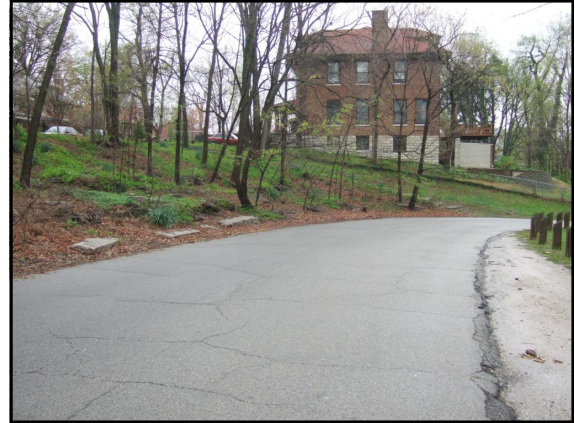
2. View of Tyler Park Drive from Baxter Ave., looking northeast, alligator cracks, shoulder raveling at gravel parking area

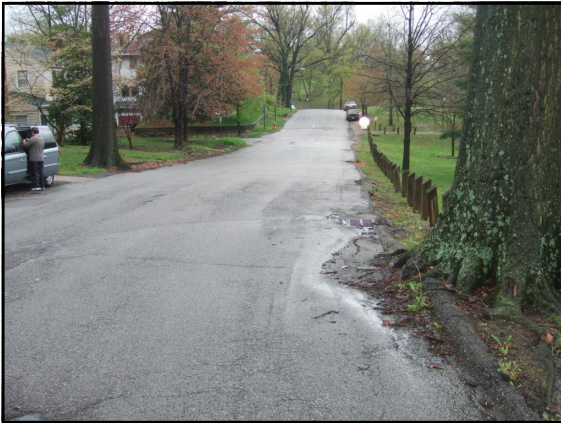
9. Asphalt cracks near large tree along Tyler Park Drive

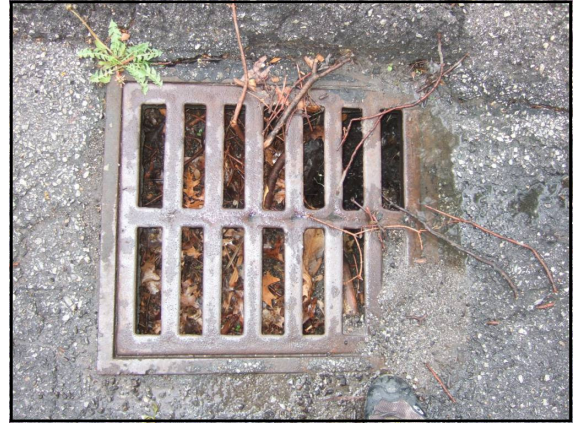
10. Catch basin clogged with leaves

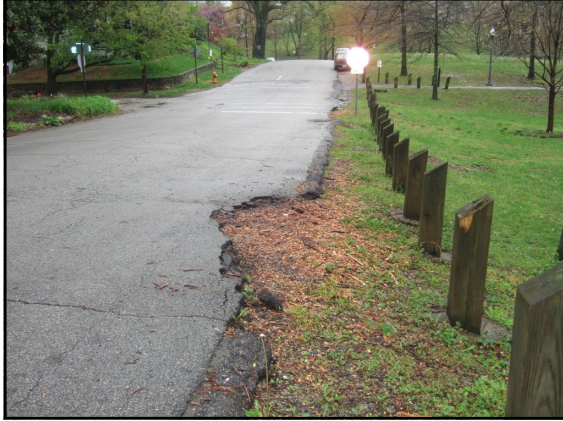
13. Missing asphalt section along the west edge of Tyler Park Drive

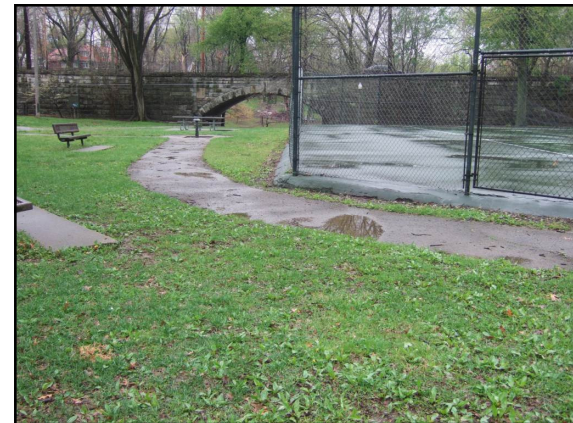
18. Standing water on sidewalk east of north tennis courts

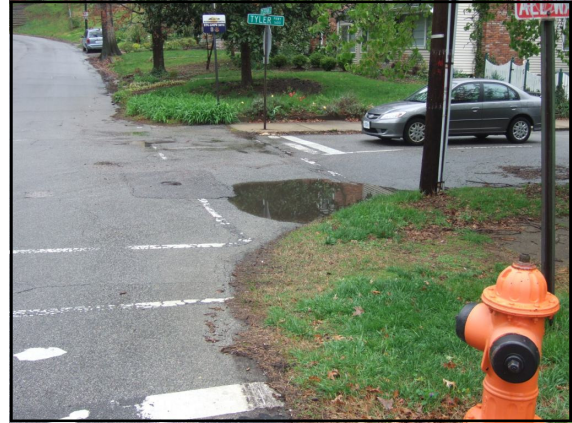
22. Standing water at intersection of Tyler Park Drive and Tyler Parkway

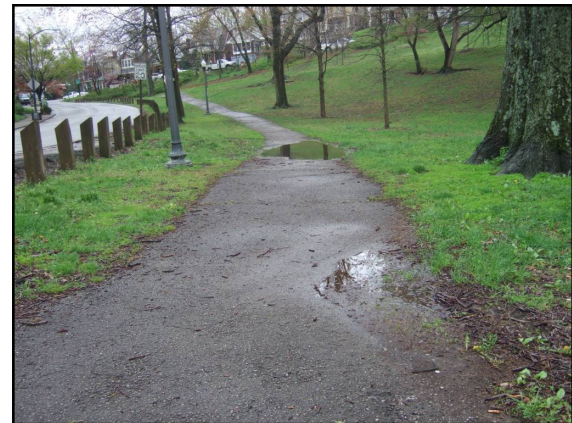
24. Sidewalk into park along Tyler Park Drive, standing water near lightpole

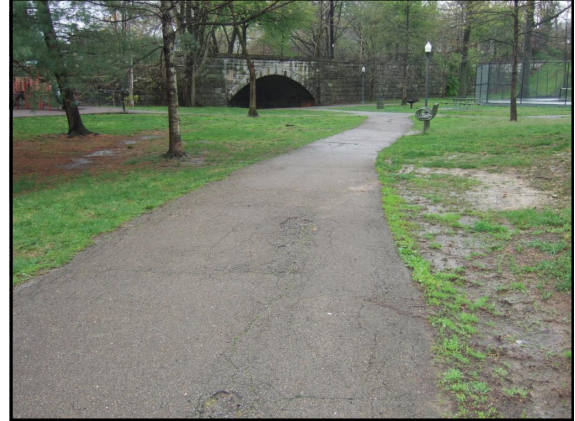
32. Sidewalk leading to tunnel beneath Baxter Ave, minor cracking, poor drainage to the northeast

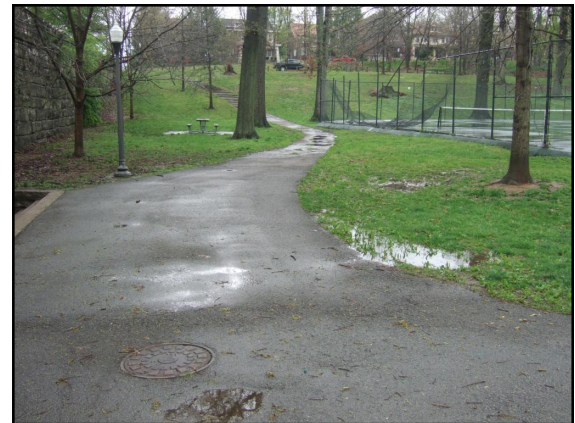
36. Standing water near edge of pavement at east end of tunnel

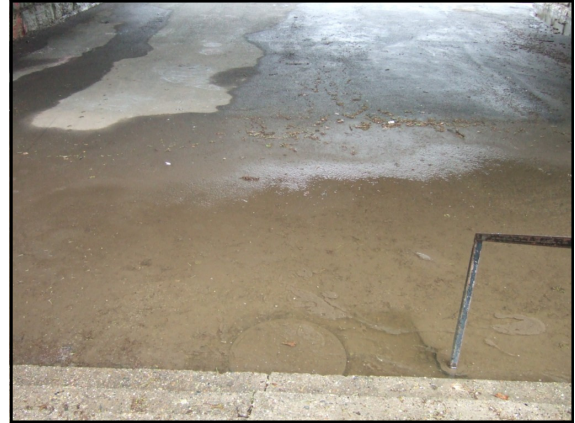
38. Standing water at base of stairs, manhole submerged

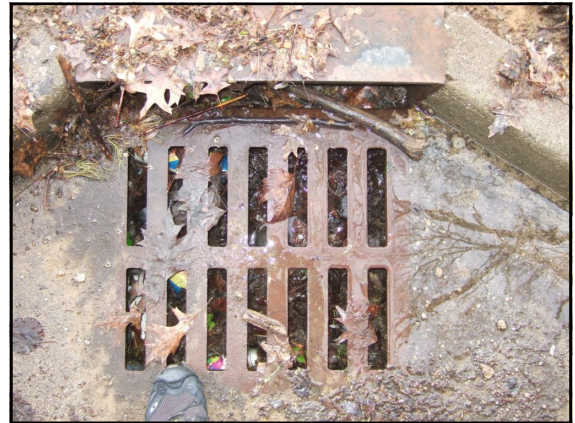
40. Leaves and debris clogging catch basin

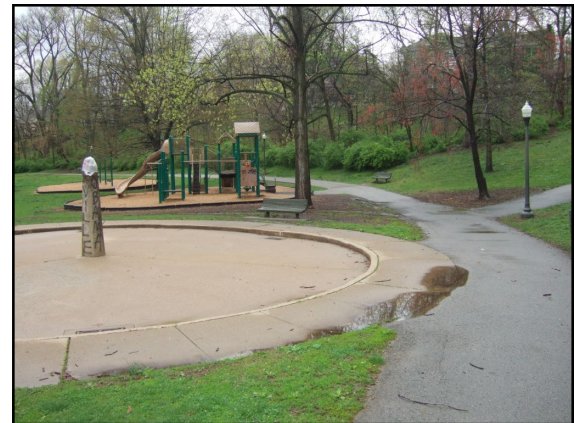
42. Standing water along east edge of spray fountain

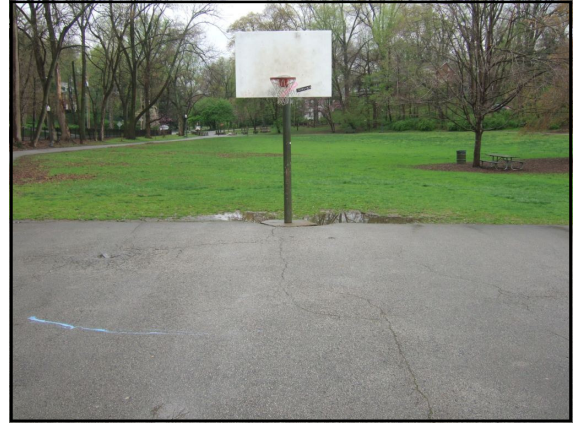
46. Poor drainage behind basketball goal

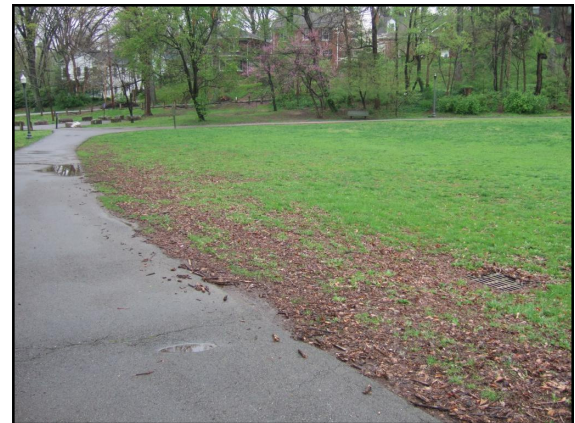
48. Standing water on sidewalk, catch basin to the right

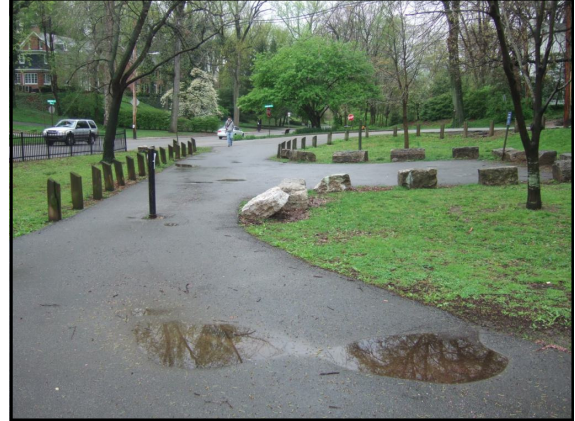
50. Puddles near west entrance

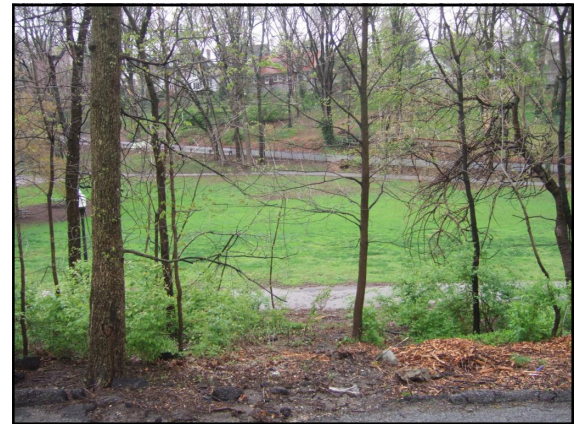
52. View of erosion from Tyler Park Drive

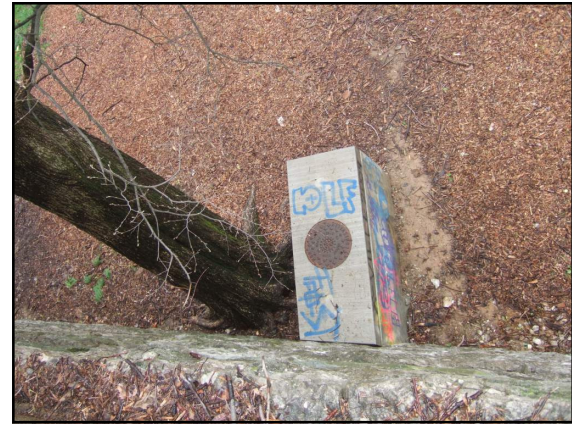
60. View of above-grade manhole box, from Baxter Ave.

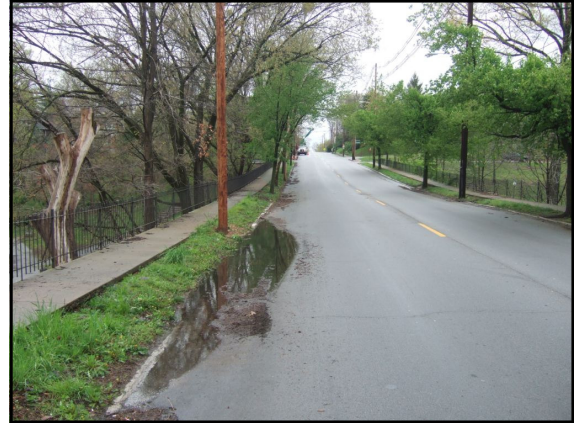
62. Standing water on southwest side of Baxter Ave.

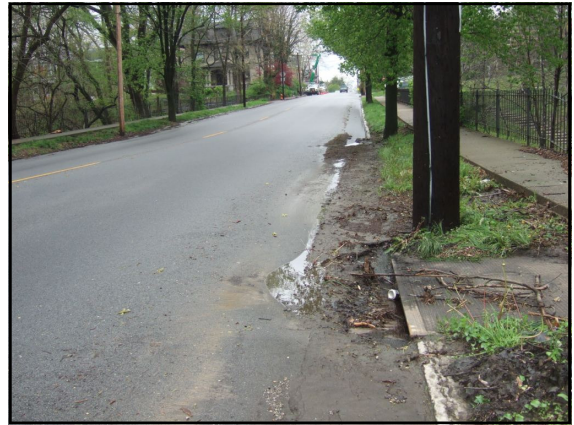
70. Poor roadside drainage, partially clogged curb inlet along northeast side of Baxter Ave.

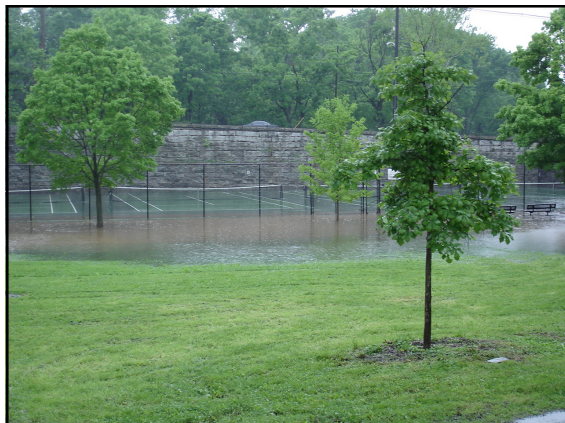
71. Severe ponding east of the south tennis courts

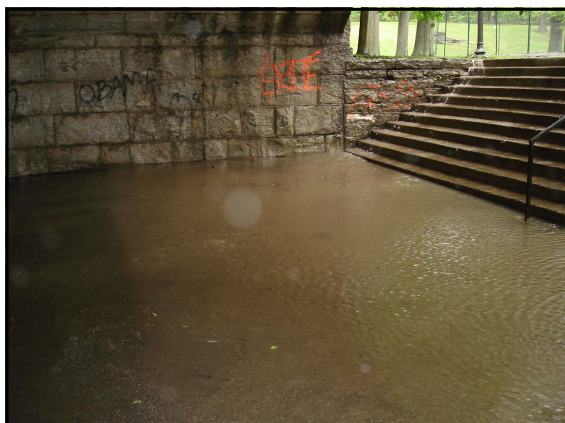
73. Standing water at base of stairs on east side of tunnel

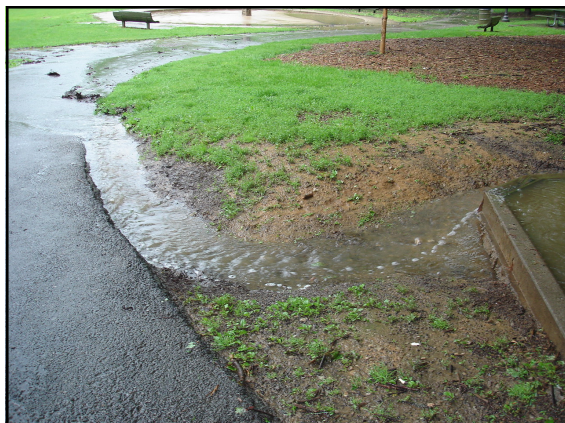
75. Stream of water from overflow at catch basin, west entrance of tunnel
