# TYLER PARK

## RENEWAL MASTER PLAN

OCTOBER 2010

ENVIRONS INC LANDSCAPE ARCHITECTS  
HERITAGE LANDSCAPES LLC  
MATTINGLY ENGINEERS, LLC  
STUDIO KREMER ARCHITECTS

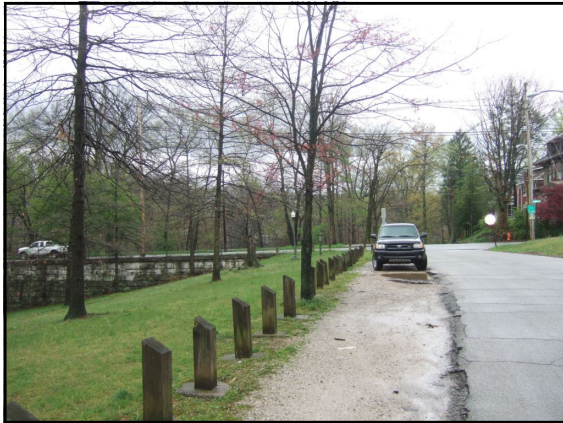
3. Gravel parking area along Tyler Park Drive, near intersection with Baxter Ave.

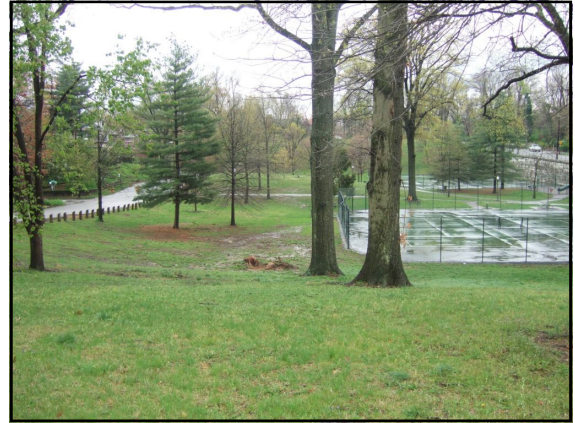
4. View of park from Tyler Park Drive, looking southeast, standing water east of north tennis courts

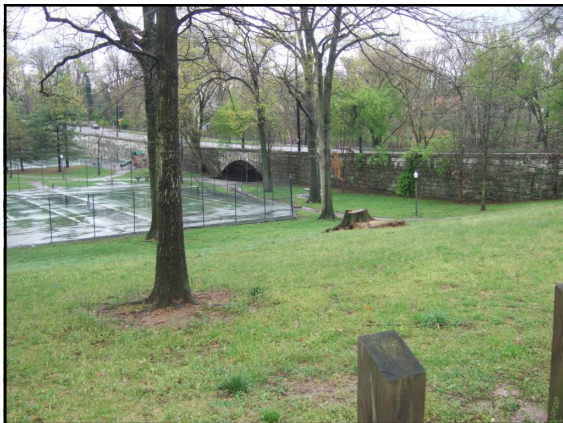
5. View of park from Tyler Park Drive, looking south

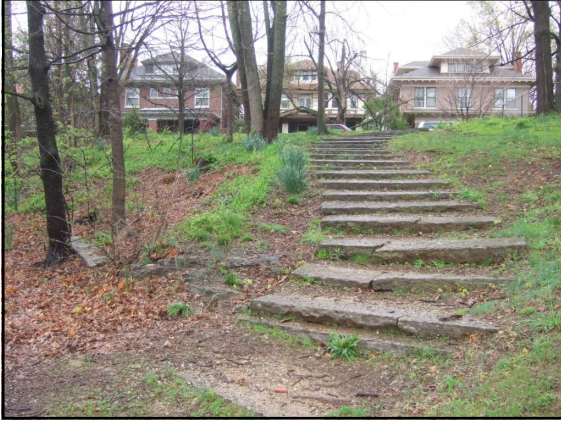
7. Stairs from Windsor Place, northeast of park

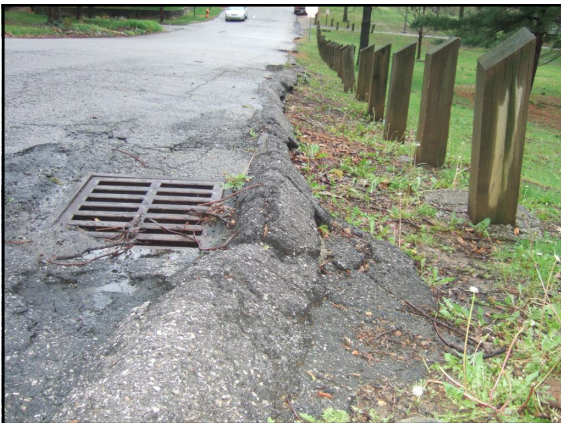
11. Catch basin along Tyler Park Drive, looking southeast

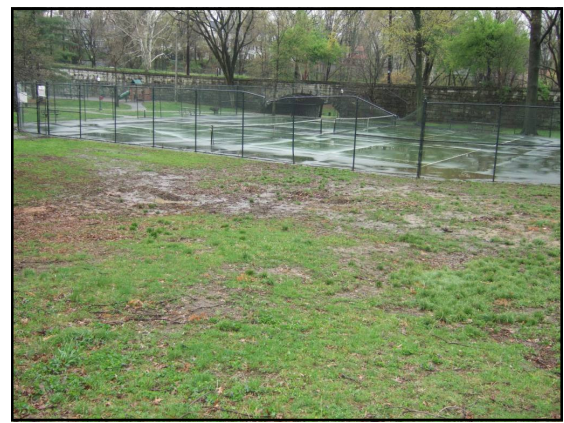
12. View of poor drainage east of north tennis courts

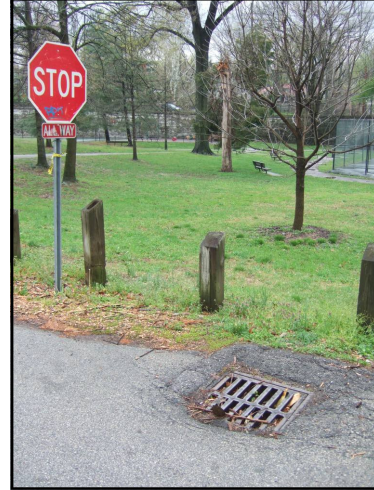
14. Catch basin near the intersection of Tyler Park Drive and Tyler Parkway

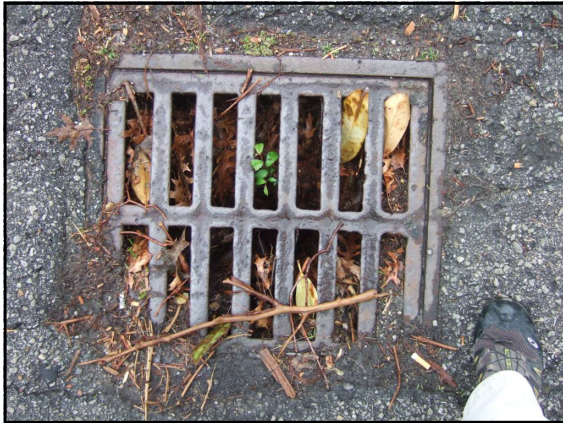
15. Catch basin clogged with leaves

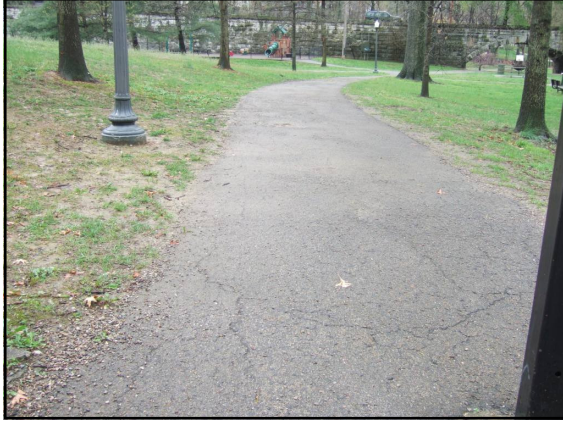
19. Sidewalk into park from the intersection of Tyler Park Drive and Tyler Parkway

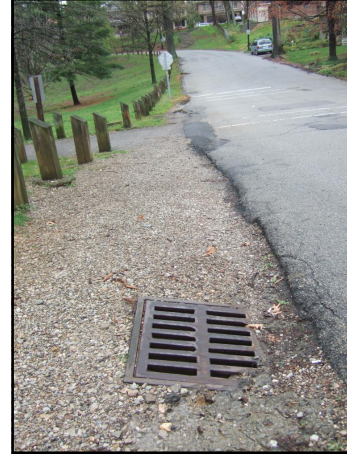
20. Catch basin in gravel shoulder along Tyler Park Drive

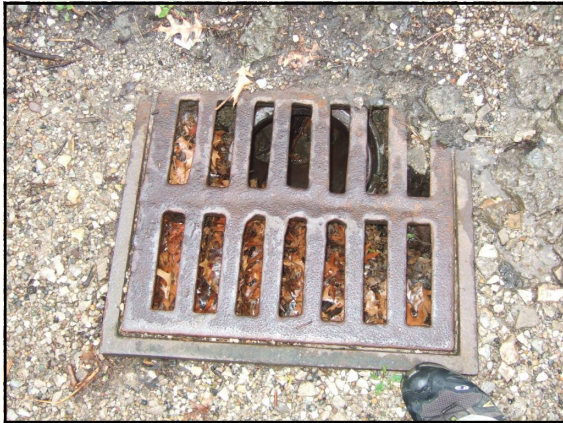
21. Leaves clogging catch basin, with outlet pipe primarily clear

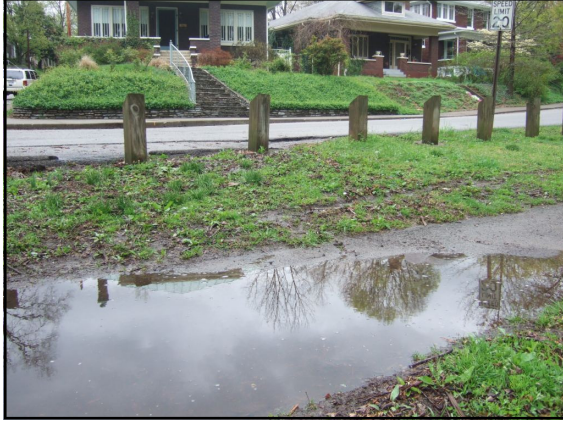
25. Standing water near lightpole

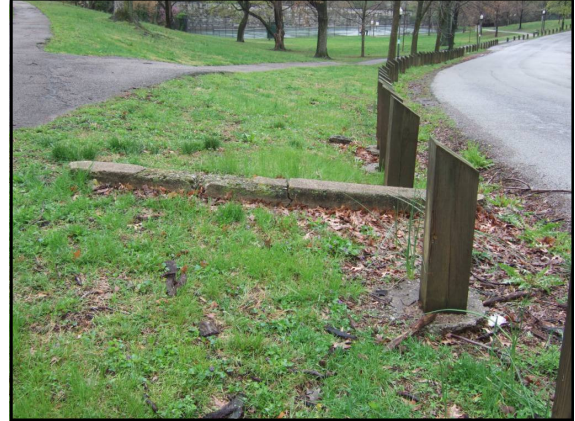
26. Concrete headwall near southeast corner of park

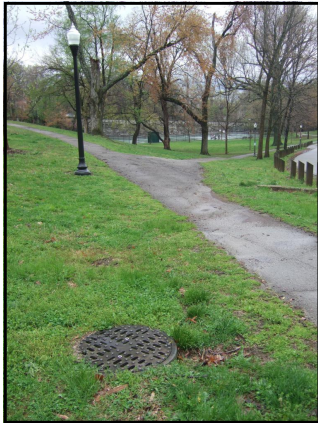
27. Combined sewer manhole at southeast corner of park

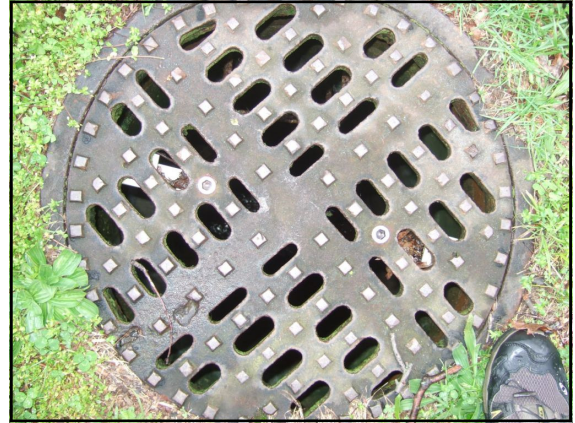
28. Closeup of combined sewer manhole

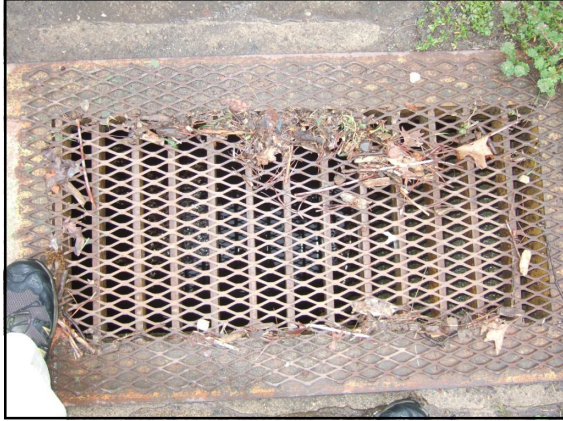
31. Closeup of catch basin

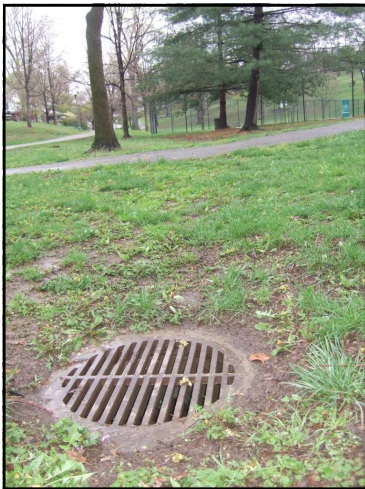
33. Catch basin between south tennis courts and tunnel

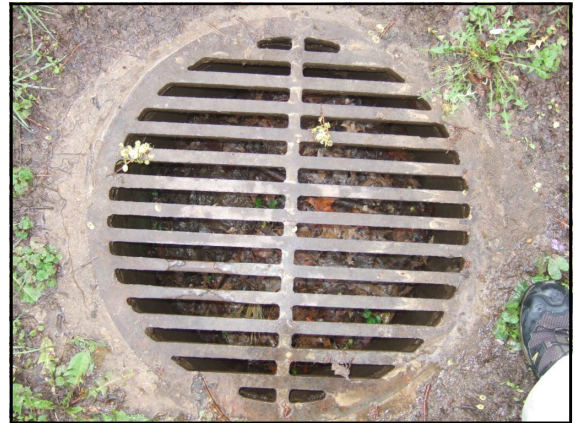
34. Closeup of catch basin

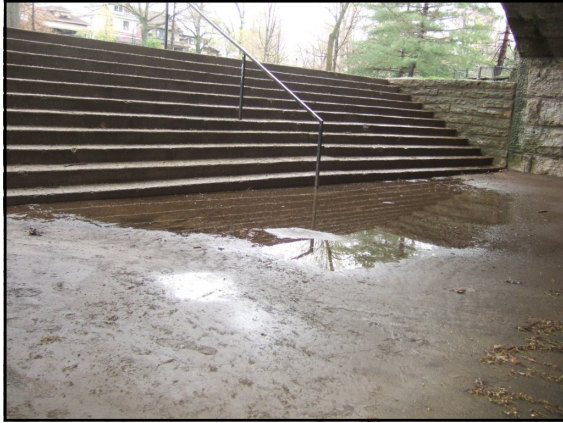
37. Standing water at base of stairs, east entrance to tunnel

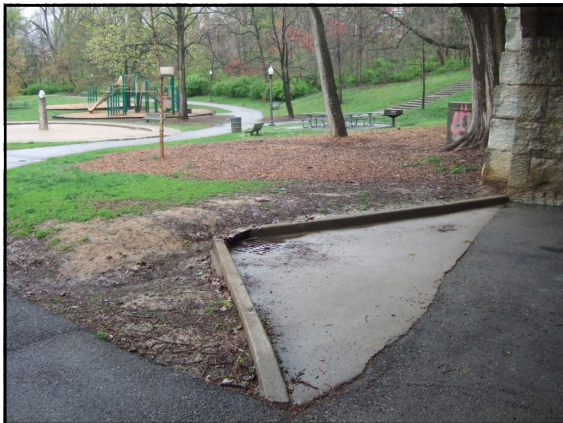
39. Catch basin at west entrance to tunnel

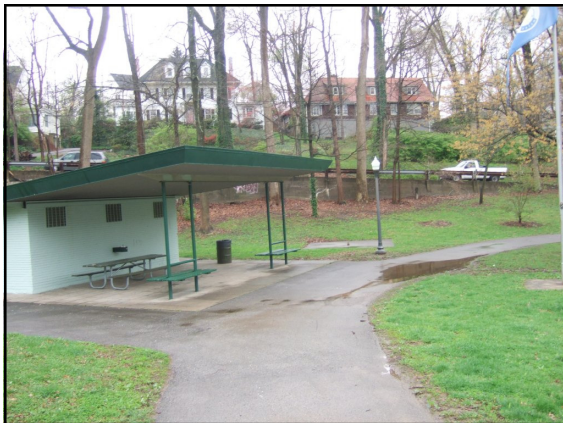
41. Standing water on sidewalk in front of bathroom

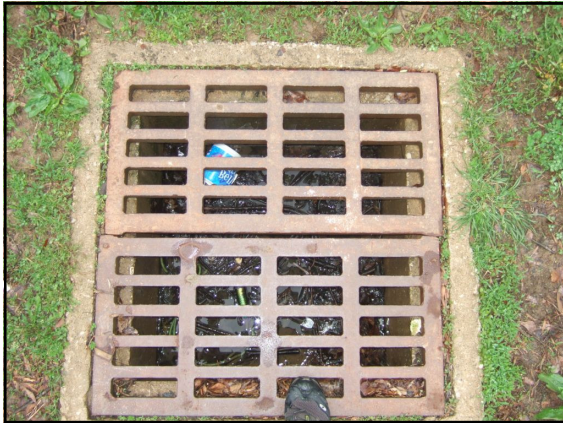
45. Catch basin south of spray fountain, leaves and debris floating

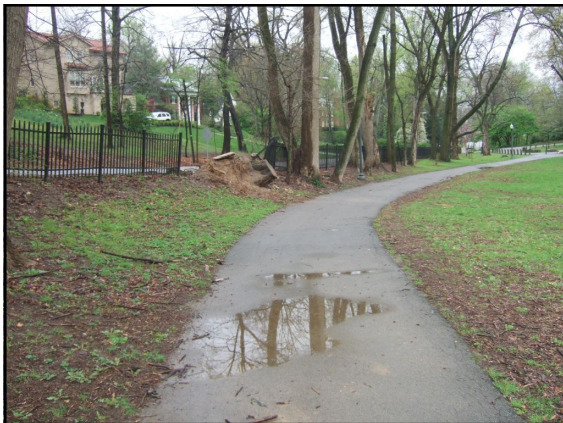
47. Standing water on sidewalk near Castlewood Ave.

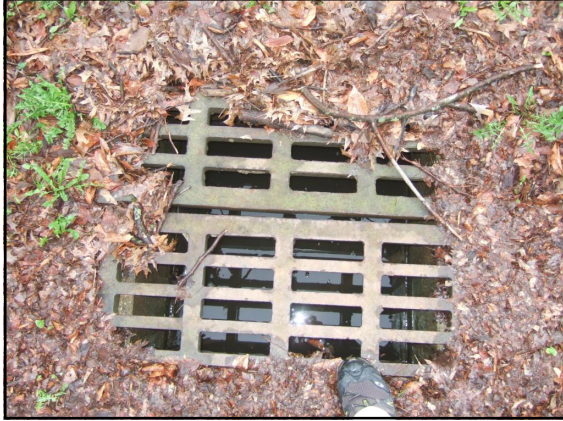
49. Closeup of catch basin

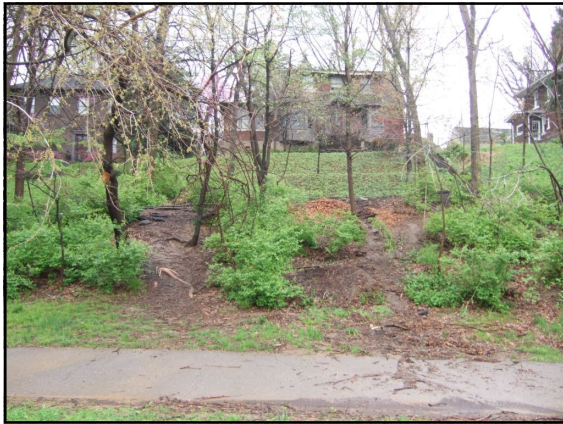
51. Erosion on slope north of west side of park, runoff coming from Tyler Park Drive

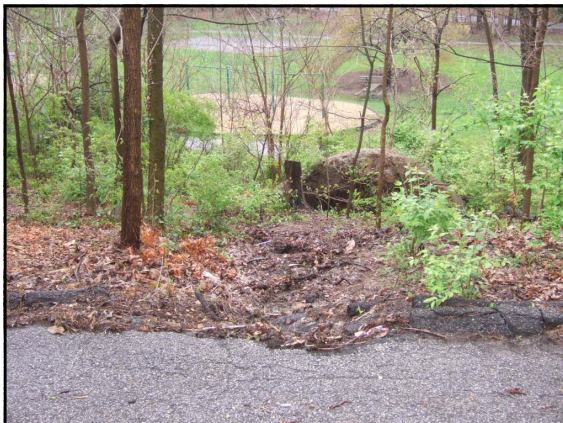
53. Erosion of slope, from Tyler Park Drive runoff

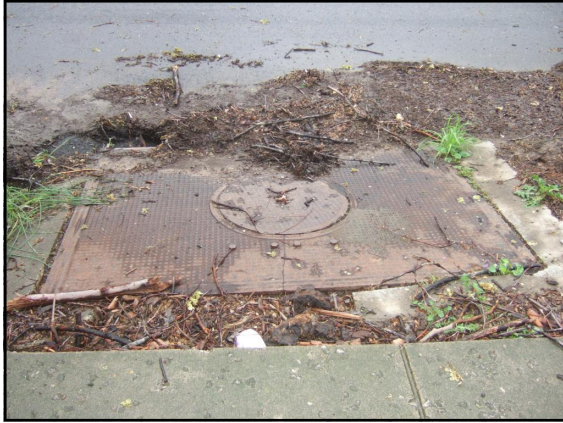
61. Clogged curb inlet along Baxter Ave.

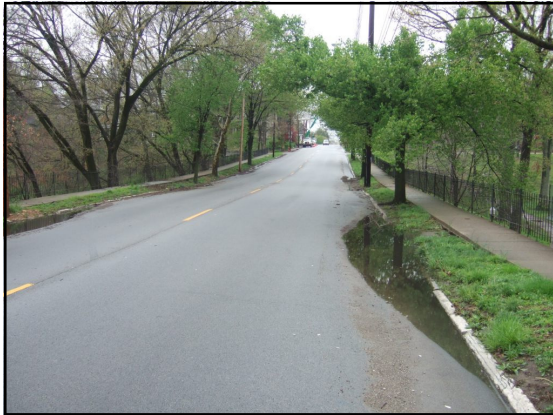
63. Standing water along northeast side of Baxter Ave.

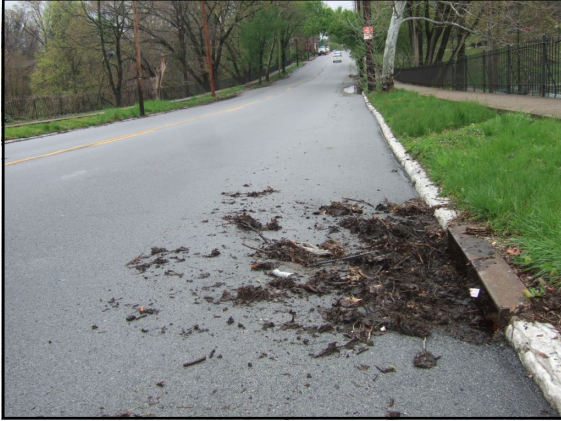
67. Debris and leaves cleared from curb inlet along northeast side of Baxter Ave.

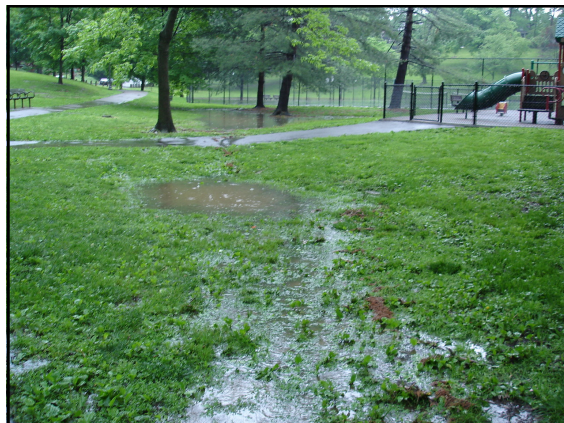
72. Standing water at catch basin between south tennis courts and tunnel

- (3) minor regrading in low spots where water ponds and directing surface drainage to selected low areas, which can be enhanced as natural stormwater features. These features, such as rain gardens and bioswales, will act as natural filters for pollutants and sediment and will help slow down the runoff before reaching the stormwater system. It should be noted that these improvements would provide only minimal storage capacity and have an impact on smaller storm events only. More significant upgrades to the stormwater system are required to impact larger rain events.

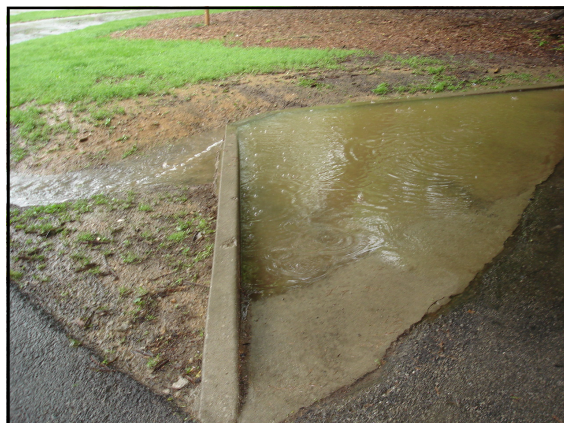
74. Standing water at catch basin, west entrance of tunnel

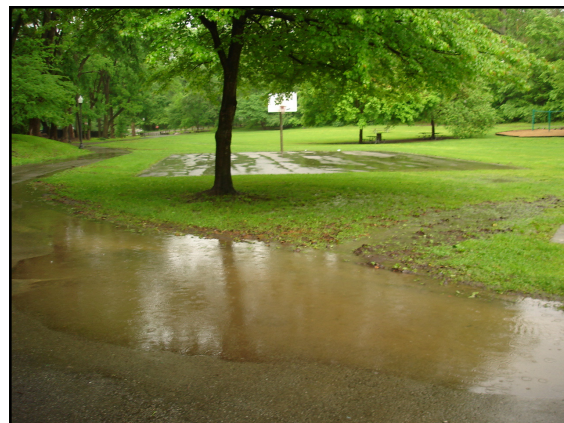
76. Poned water on walkway in front of bathrooms
