# TYLER PARK

## RENEWAL MASTER PLAN

OCTOBER 2010

ENVIRONS INC LANDSCAPE ARCHITECTS  
HERITAGE LANDSCAPES LLC  
MATTINGLY ENGINEERS, LLC  
STUDIO KREMER ARCHITECTS

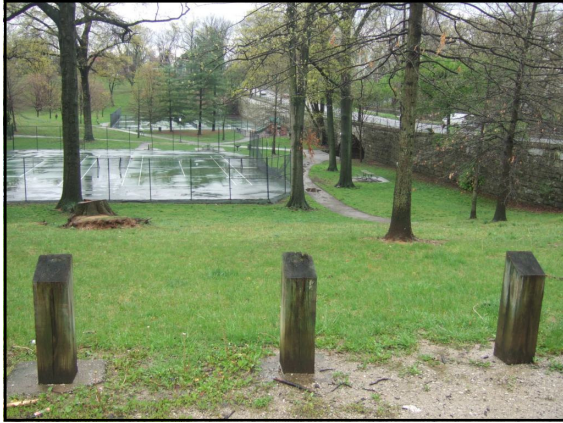
1. View of north tennis courts from Tyler Park Drive, looking southeast

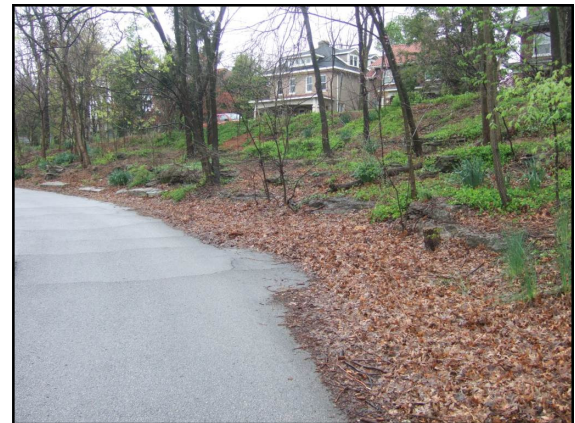
6. Landscaped hillside north of park along Tyler Park Drive

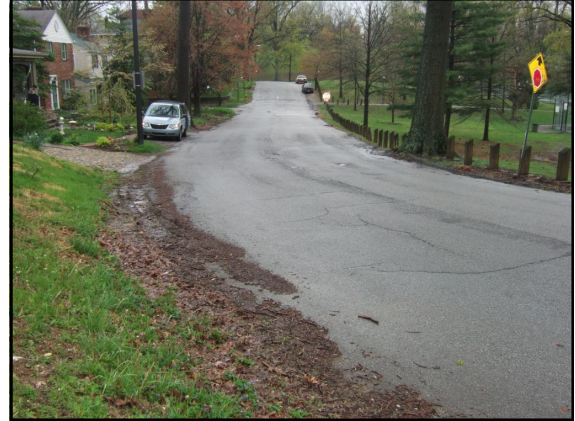
8. View of Tyler Park Drive east of park, looking southeast

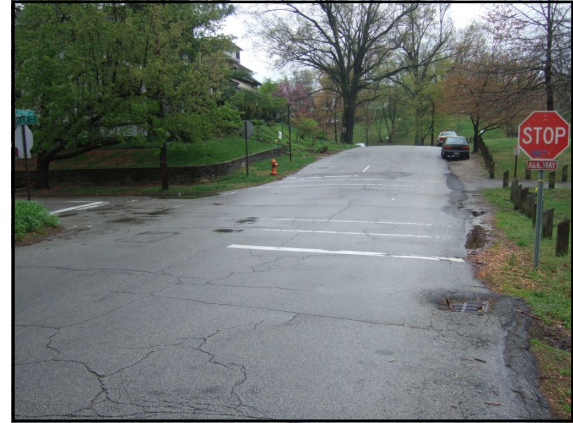
16. Intersection of Tyler Park Drive and Tyler Parkway to the east

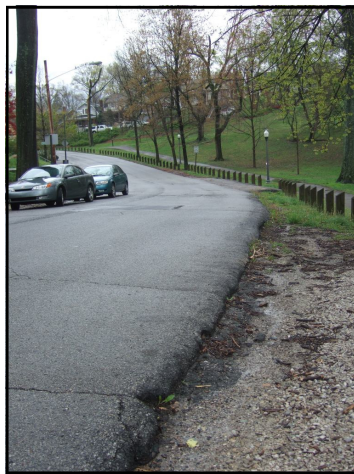
23. Drop-off from asphalt to gravel parking area along Tyler Park Drive

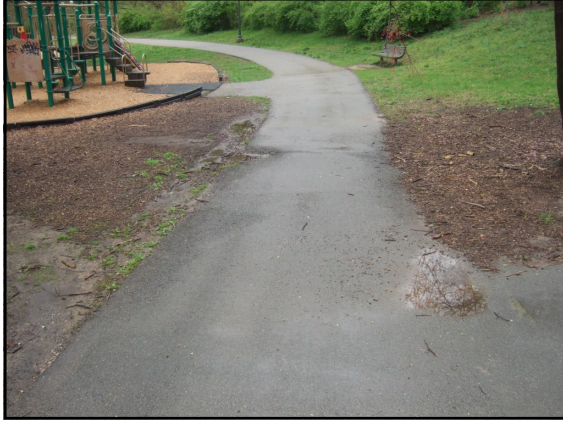
43. Standing water at edge of sidewalk near spray fountain and playground

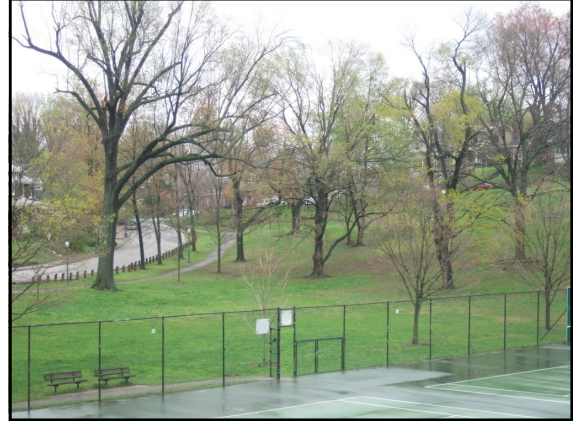
68. View of park from Baxter Ave., looking east
